Manhole Inspection Summary

Manhole # S21AA2019MH

Insp Date: **11/20/06 1:48 PM**

Location Address: **5520 MATTFELDT AVE**

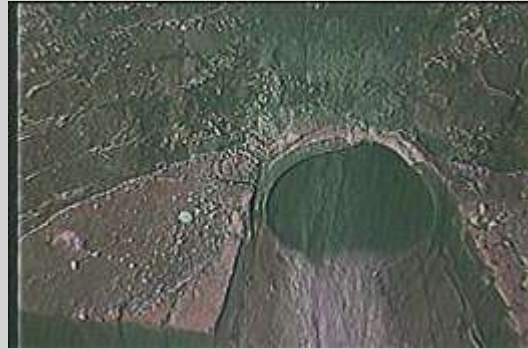
Drop In @ 7 O'Clock

Rod and Bar (Angled)

Pipe Material: **Clay**

Infiltration: **None**

Pipe Seal Cond: **Broken**

Drop Condition: **Open**
